The curious case of the cracked upper centrals

Janine Sohota explains how she repaired large buccal fracture lines in both central incisors that extended subgingivally and also palatal

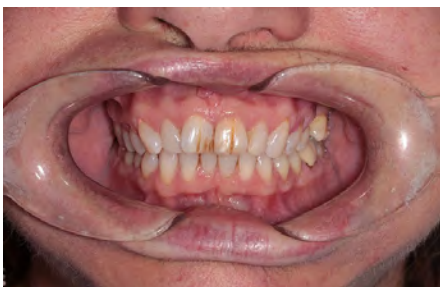
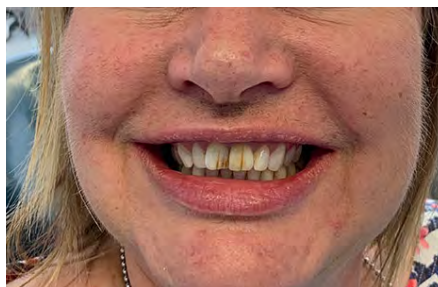
Over time, the patient noticed the cracks deepening, and the level of staining associated with the fracture lines was becoming unsightly (Figure 1).

Figure 1: The patient noticed cracks deepening, and the level of staining associated with the fracture lines was becoming unsightly

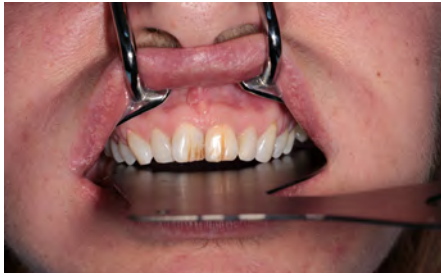
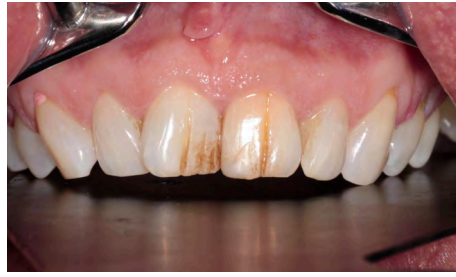
The patient had been aware of the fracture lines for many years but the aetiology was unknown. The fracture line was approximately 2mm wide and had a depth of 2-3mm in places (Figures 2 and 3).

Figures 2 and 3: The fracture line was approximately 2mm wide and had a depth of 2-3mm in places

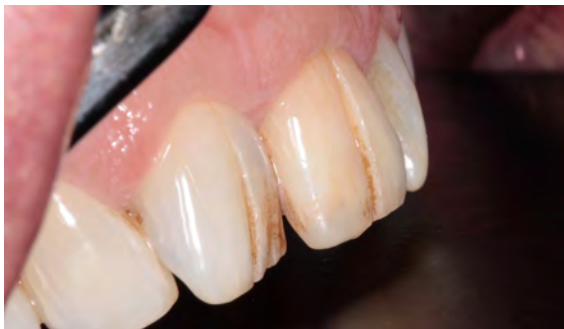
There was no doubt this was a complex case, but at this stage with the cracks expanding there was imminent and inevitable risk of vertical root fracture long term. Hence, treatment was needed not only to improve aesthetics, but also to save the upper centrals (Figure 4).

Figures 4 and 4a: With the cracks expanding there was imminent and inevitable risk of vertical root fracture long term

I took a periapical film, the UR1 had no pathology or evidence of a root fracture. The UL1 had been previously root filled, although there was no apical area, the root filling was short (Figure 4a).

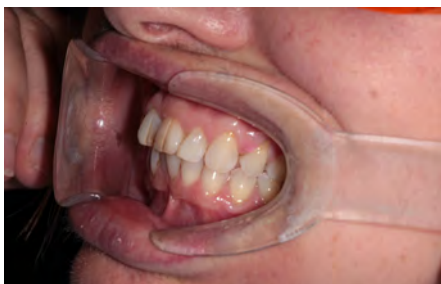
A full examination was completed along with clinical photographs and radiographs, the patient had an incisal relationship of class 2 div 1 with bilateral class 1 molar relationship (Figure 5).

Figure 5: The patient had an incisal relationship of class 2 div 1 with bilateral class 1 molar relationship

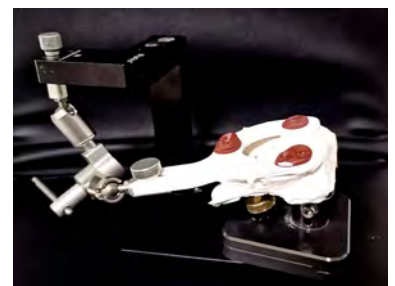
Figure 5a:

A facebow was taken using the Artec system (Figure 5a).

'The purpose of a facebow is to register the relationship of the patient's maxillary arch in three planes of space and transfer this information into an articulator that can be adjusted to simulate the patient's jaw movements. The relationship is two-fold: to establish the functional relationship of the maxillary arch to the axis of rotation for proper function and to analyse the aesthetic relationship of the maxillary arch to the patient's face for optimal aesthetics.' (Lee, 2012)

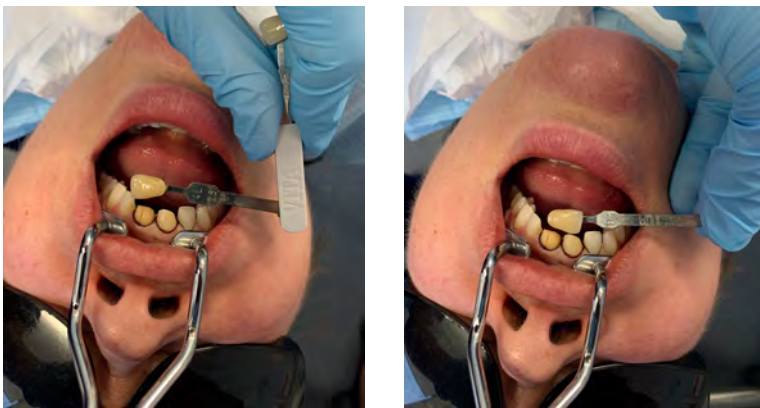
I prepped the two centrals with subgingival margins (chamfers all round). I requested a Dawson stop palatally on both crowns to ensure anterior guidance (Figure 6/6a). Two-stage putty wash impressions were taken with retraction cord. The stump shade was noted.

Figures 6 and 6a: I requested a Dawson stop palatally on both crowns to ensure anterior guidance

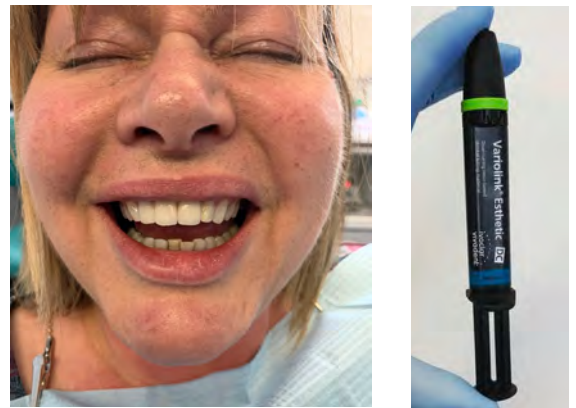
Figure 6b: I requested that the lab send me the work back unglazed

I requested that the lab send me the work back unglazed (biscuit bake). This would allow me to assess shading/translucency/occlusion and shape in order to make changes as required (Figure 6b).

On the try in appointment I used the Variolink try-in paste. I was pleased that the dark core of the UL1 was not shining through, however I felt the shading was too pale. It lacked the warmth of the natural teeth. Also, the patient had natural lines/micro fractures within the enamel of her adjacent teeth. I requested some of these effects to be added.

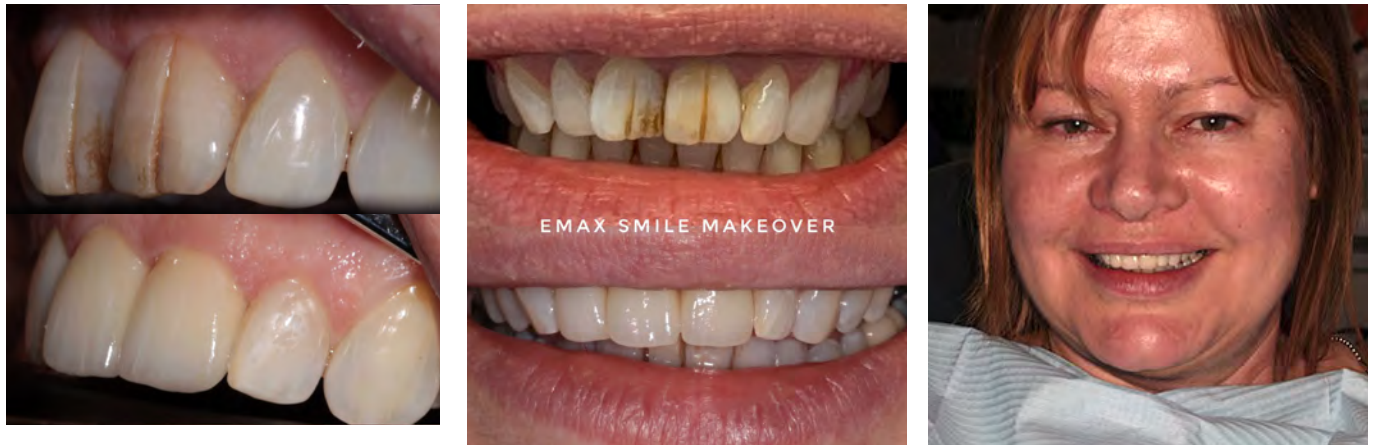
Figures 8-10: Final crowns in situ

These crowns were bonded on using Variolink DC luting system by Ivoclar Vivadent.
