# The curious case of the cracked upper centrals

**Janine Sohota** explains how she repaired large buccal fracture lines in both central incisors that extended subgingivally and also palatally

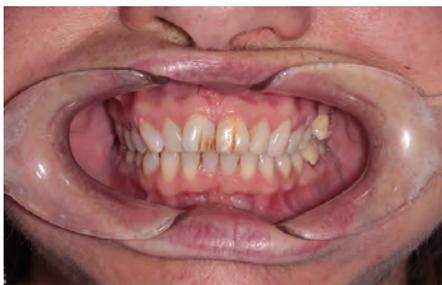
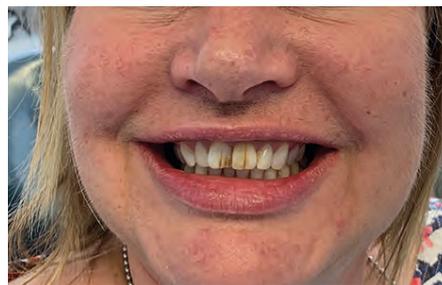
**Figure 1:** The patient noticed cracks deepening, and the level of staining associated with the fracture lines was becoming unsightly

Over time, the patient noticed the cracks deepening, and the level of staining associated with the fracture lines was becoming unsightly (Figure 1).

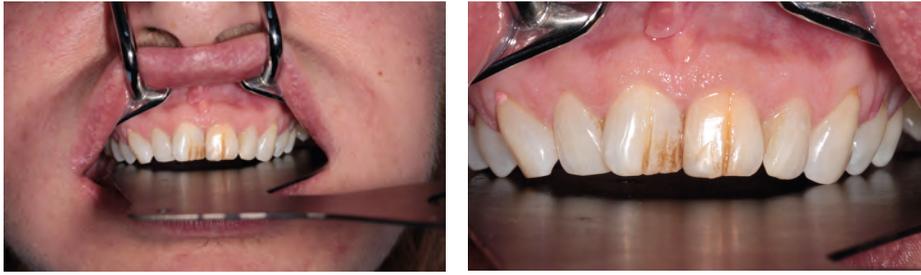
**Figures 2 and 3:** The fracture line was approximately 2mm wide and had a depth of 2-3mm in places

The patient had been aware of the fracture lines for many years but the aetiology was unknown. The fracture line was approximately 2mm wide and had a depth of 2-3mm in places (Figures 2 and 3).

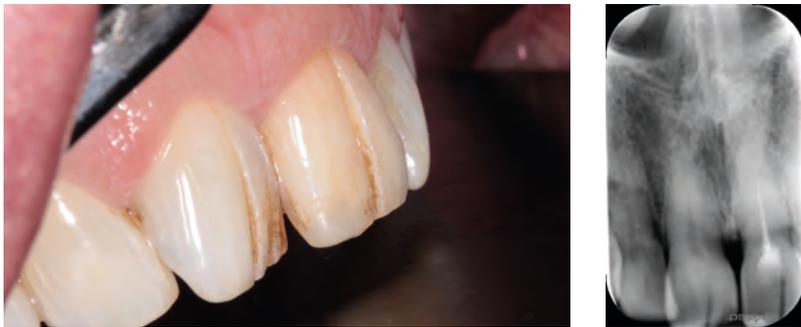
**Figures 4 and 4a:** With the cracks expanding there was imminent and inevitable risk of vertical root fracture long term

There was no doubt this was a complex case, but at this stage with the cracks expanding there was imminent and inevitable risk of vertical root fracture long term. Hence, treatment was needed not only to improve aesthetics, but also to save the upper centrals (Figure 4).

I took a periapical film, the UR1 had no pathology or evidence of a root fracture. The UL1 had been previously root filled, although there was no apical area, the root filling was short (Figure 4a).

- Hygienist visits to remove subgingival/supragingival deposits and full oral hygiene instruction
- Refer to an endodontist for re-root canal treatment of the short root filled UL1. Although there was no apical pathology, I was not satisfied with the longevity of the root filling, which was placed some years ago. I could not risk of a future apical area or abscess once a crown had been placed
- Impressions for study models and clinical photographs to allow treatment planning
- A wax up was requested from the laboratory. It was decided that the retroclined UL2 could be improved with a no-prep E.max veneer. The patient was happy to consider this option in addition.

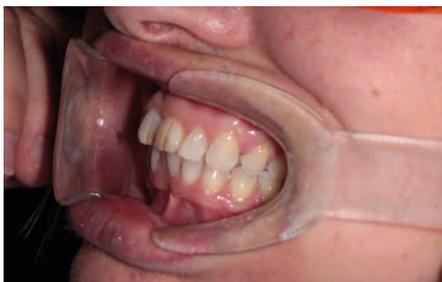
**Figure 5:** The patient had an incisal relationship of class 2 div 1 with bilateral class 1 molar relationship

A full examination was completed along with clinical photographs and radiographs, the patient had an incisal relationship of class 2 div 1 with bilateral class 1 molar relationship (Figure 5).

The lower anteriors had mild crowding, there was little incisal edge tooth wear. The temporomandibular joint and soft tissues were all healthy.

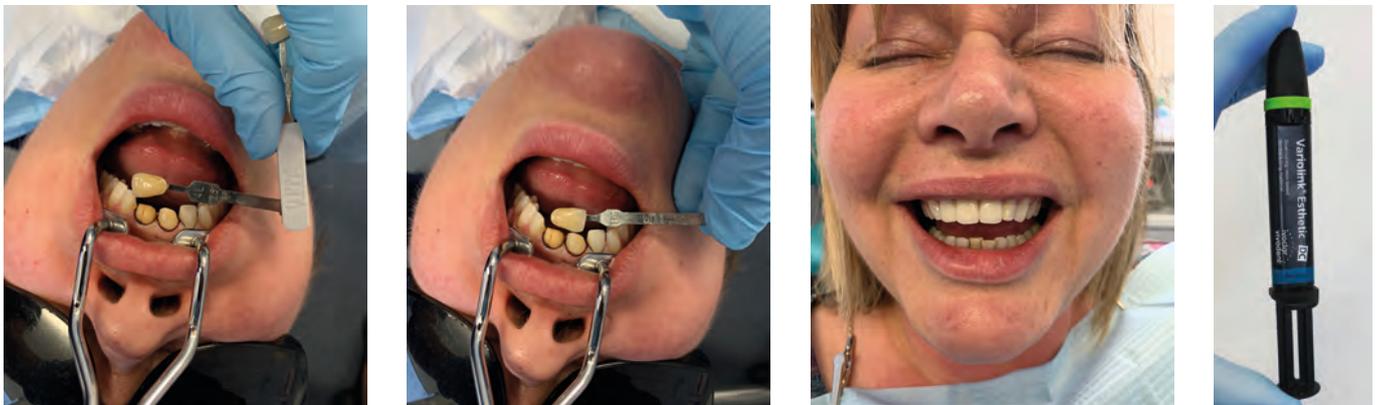
**Figures 6 and 6a:** I requested a Dawson stop palatally on both crowns to ensure anterior guidance

I prepped the two centrals with subgingival margins (chamfers all round). I requested a Dawson stop palatally on both crowns to ensure anterior guidance (Figure 6/6a). Two-stage putty wash impressions were taken with retraction cord. The stump shade was noted.

**Figure 6b:** I requested that the lab send me the work back unglazed

I requested that the lab send me the work back unglazed (biscuit bake). This would allow me to assess shading/translucency/occlusion and shape in order to make changes as required (Figure 6b).

I requested the lab to use an A2 shade for the body of the crowns with incisal translucency and a warmth with orange/brown tones cervically. A high opacity E.max ingot was used and then E.max Ceram layered over the top. A high opacity ingot was key to block out the dark stump shade of the root filled UL1.

On the try in appointment I used the Variolink try-in paste. I was pleased that the dark core of the UL1 was not shining through, however I felt the shading was too pale. It lacked the warmth of the natural teeth. Also, the patient had natural lines/micro fractures within the enamel of her adjacent teeth. I requested some of these effects to be added.
